UI GreenMetric Questionnaire

University : Kamphaeng Phet Rajabhat University
 Country : Thailand
 Web Address : www.kpru.ac.th

[4] Water (WR)

[4.5] Water pollution control in campus area

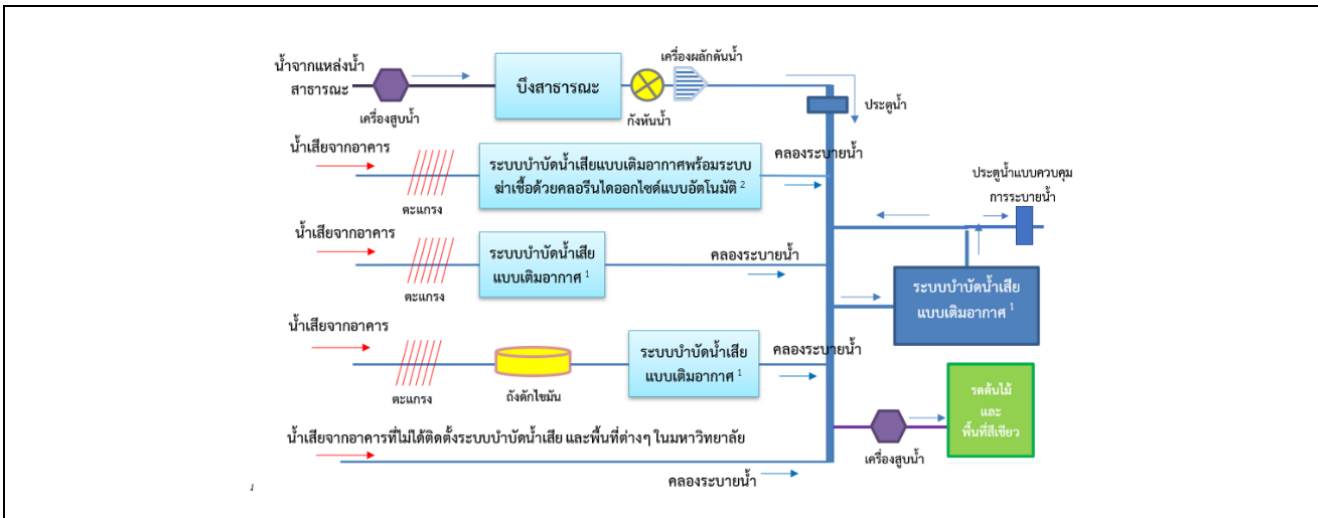
Diagram showing how treated water can be used to water plants.

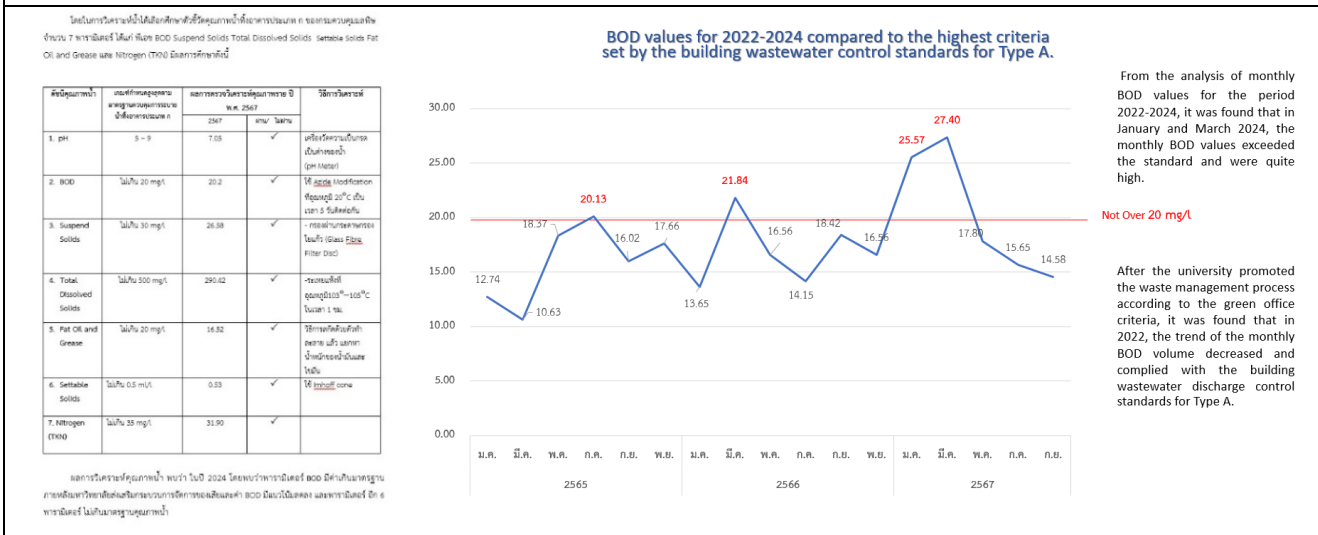
Image displaying the water quality inspection's findings

The water quality analysis results in 2024 show that after implementing waste management processes at the university, BOD levels exceeded the standard. While BOD levels may decrease over time, the other six parameters remain within water quality standards.
